CQI Home Inspections

Your Property Inspection Report

22166 Monterey Pl, Leonardtown , MD 20650

Inspection prepared for: Sample

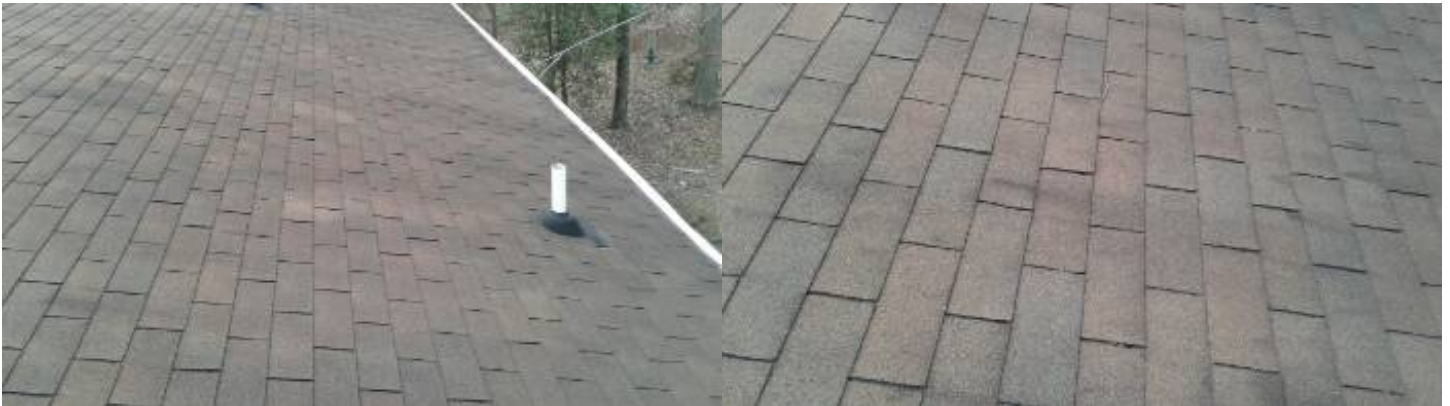
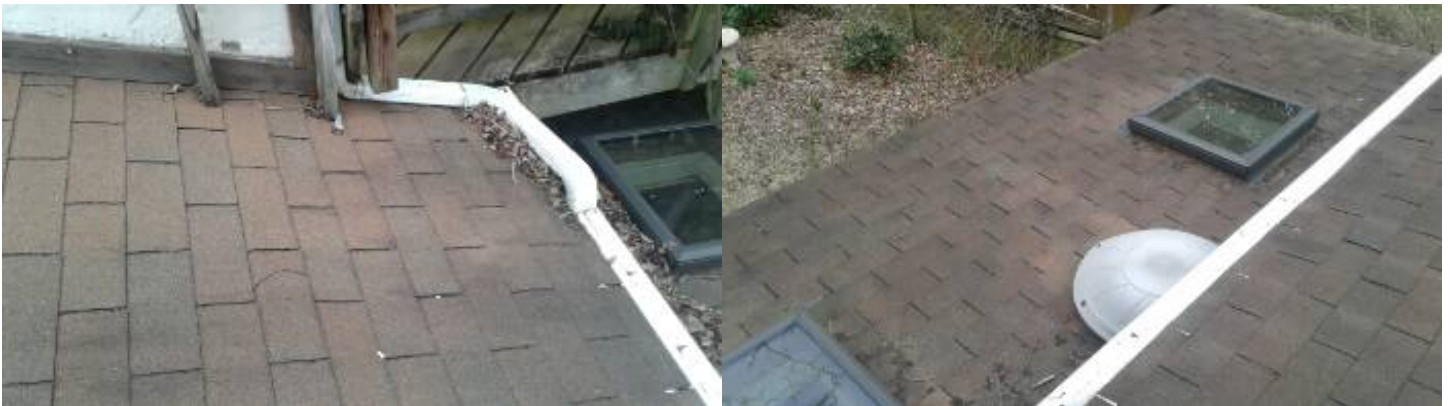
1. Roof

- **Serviceability of roof is questionable; it should be evaluated and repaired or replaced as necessary by a professional roofing contractor.**
- **Sagging / buckling on roof decking. Have evaluated repaired or replaced.**

| Exterior Areas | | |
|---|---|--|
| Page 4 Item: 1 | Roof | <ul style="list-style-type: none"> • Serviceability of roof is questionable; it should be evaluated and repaired or replaced as necessary by a professional roofing contractor. • Sagging / buckling on roof decking. Have evaluated repaired or replaced. |

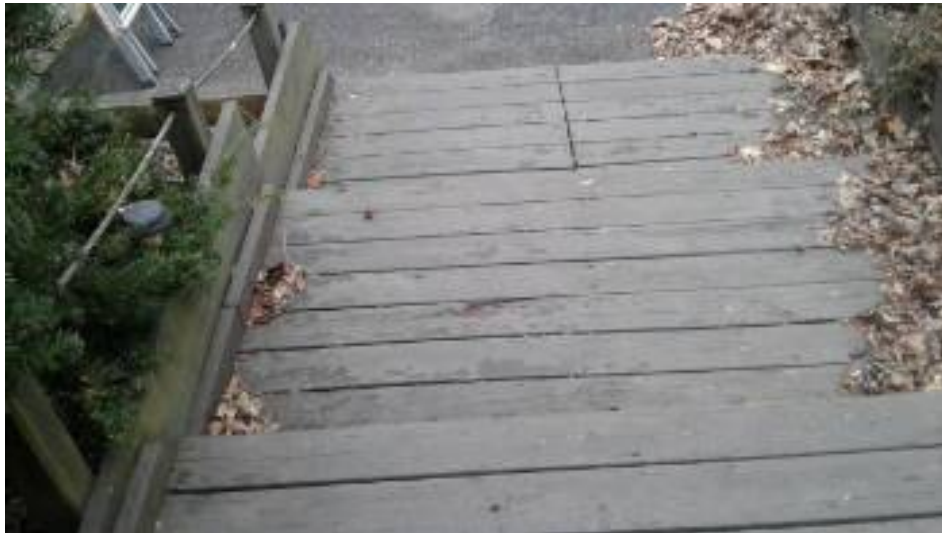
4. Drives & Walks

- **Walkways deteriorating in areas. Have evaluated**

| Exterior Areas | | |
|---|---|--|
| Page 5 Item: 4 | Drives & Walks | <ul style="list-style-type: none"> • Walkways deteriorating in areas. Have evaluated |

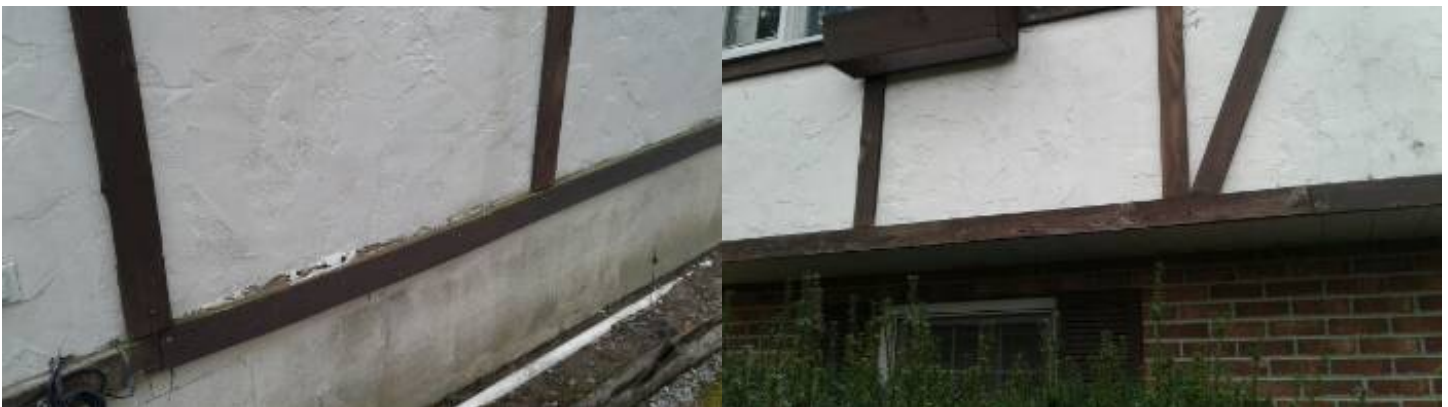
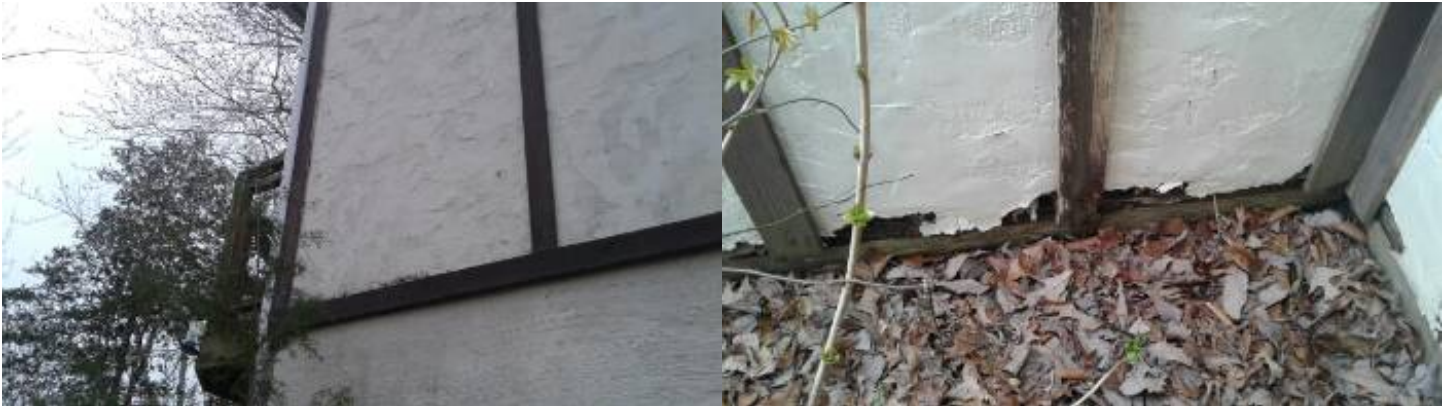
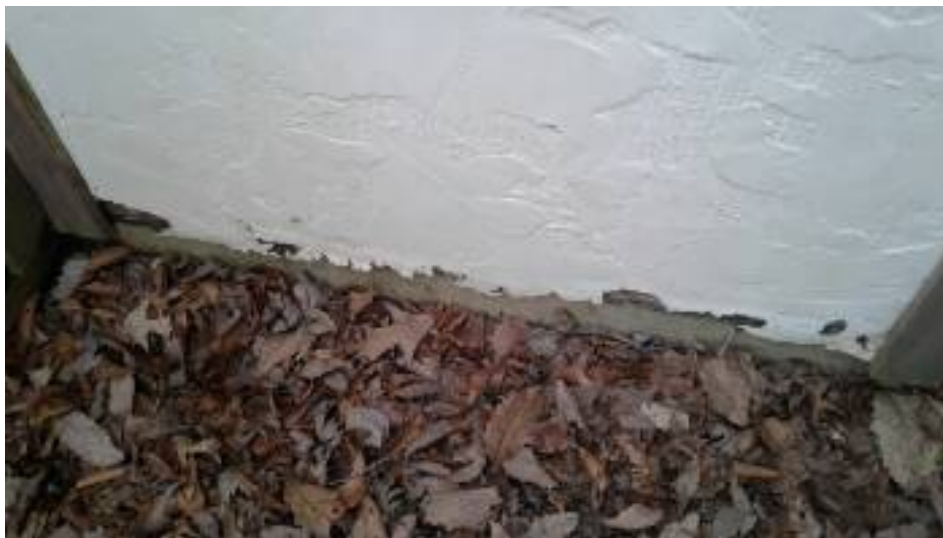
5. Siding

- **Trim areas are deteriorating in areas. Have evaluated and repaired as needed.**
- **Some composition/wood siding shows signs of water damage and swelling. Have evaluated and repaired.**
- **Termite and mud tubs noted. Have evaluated and treated.**

| Exterior Areas | | |
|---|---|--|
| Page 5 Item: 5 | Siding | <ul style="list-style-type: none"> • Trim areas are deteriorating in areas. Have evaluated and repaired as needed. • Some composition/wood siding shows signs of water damage and swelling. Have evaluated and repaired. • Termite and mud tubs noted. Have evaluated and treated. |

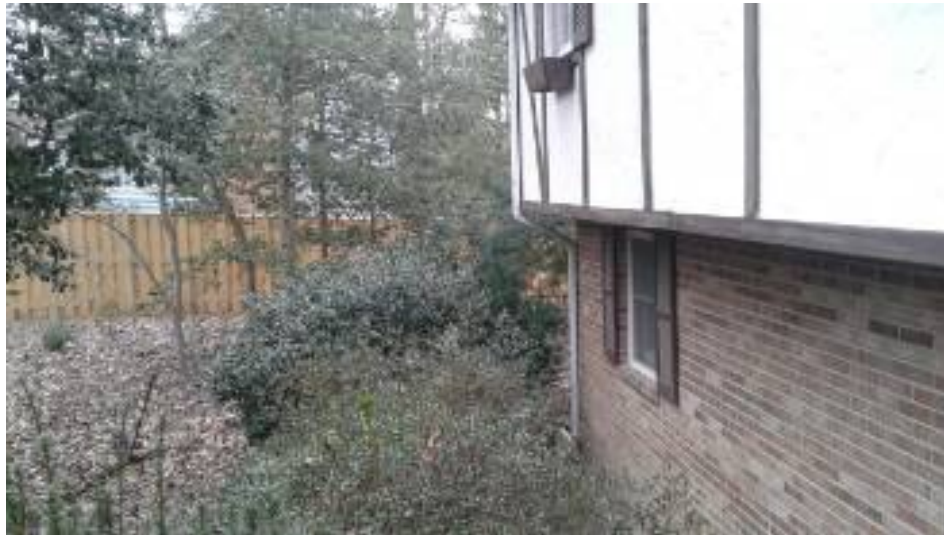
6. Vegetation

- Prune or remove any plants that are in contact or proximity to home to eliminate pathways of wood destroying insects.
- Trim trees that are in contact or proximity to home, as branches can abrade roofing or siding.

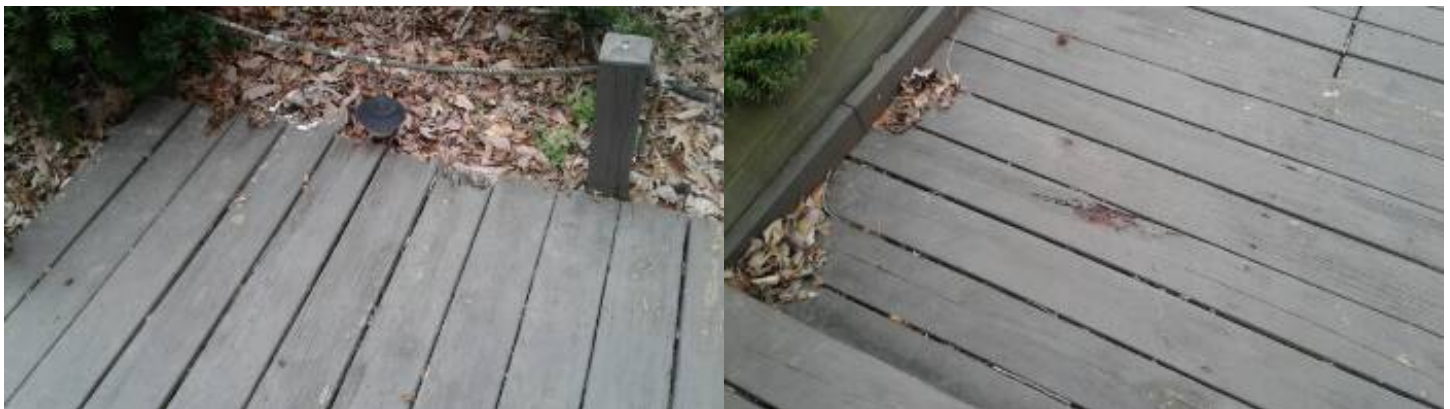
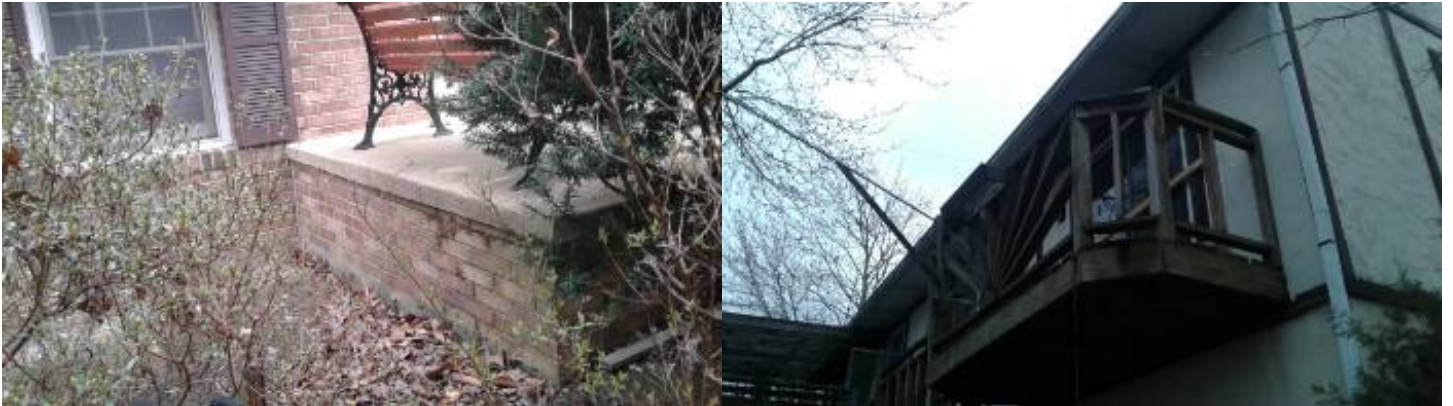
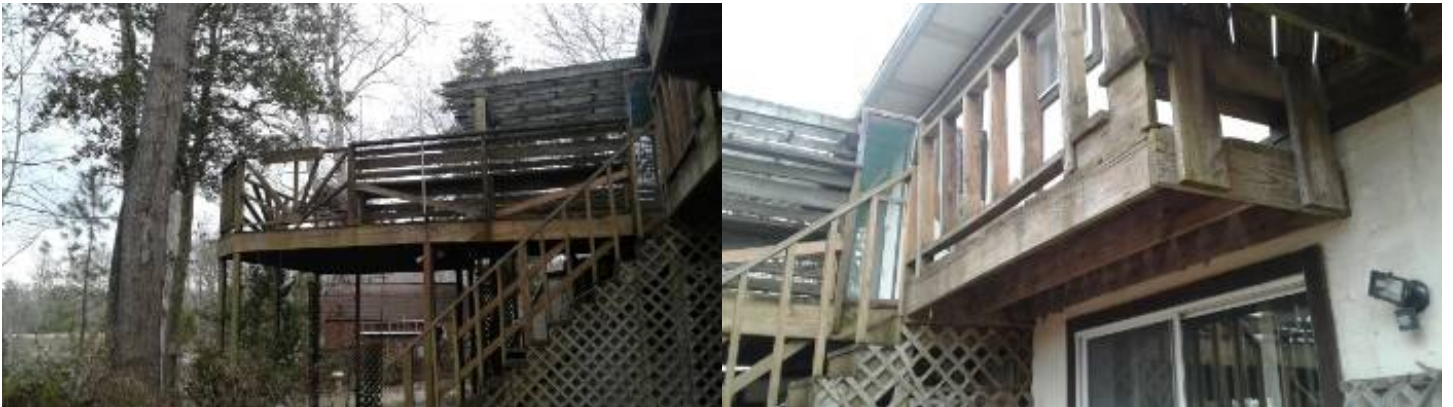
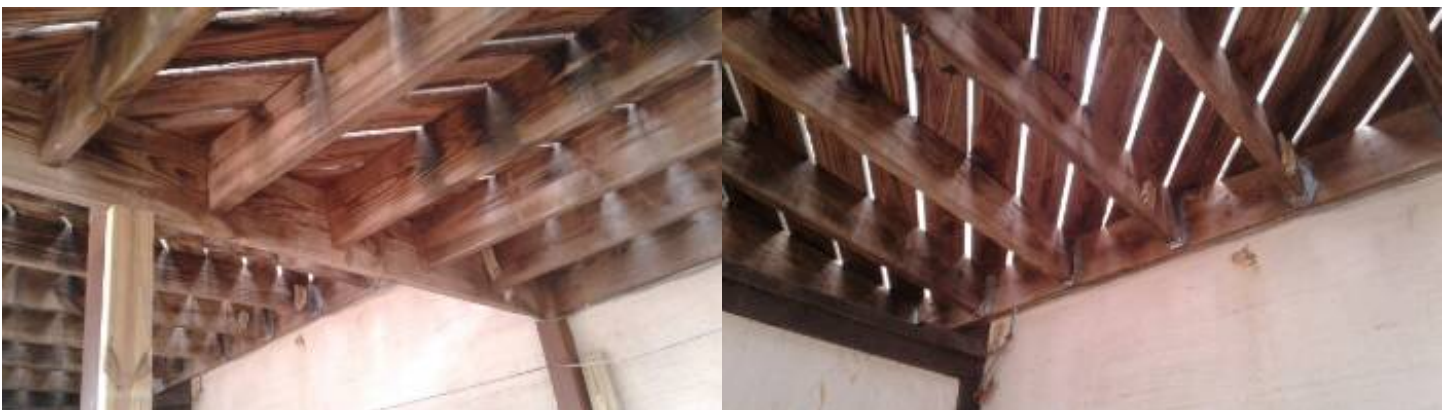
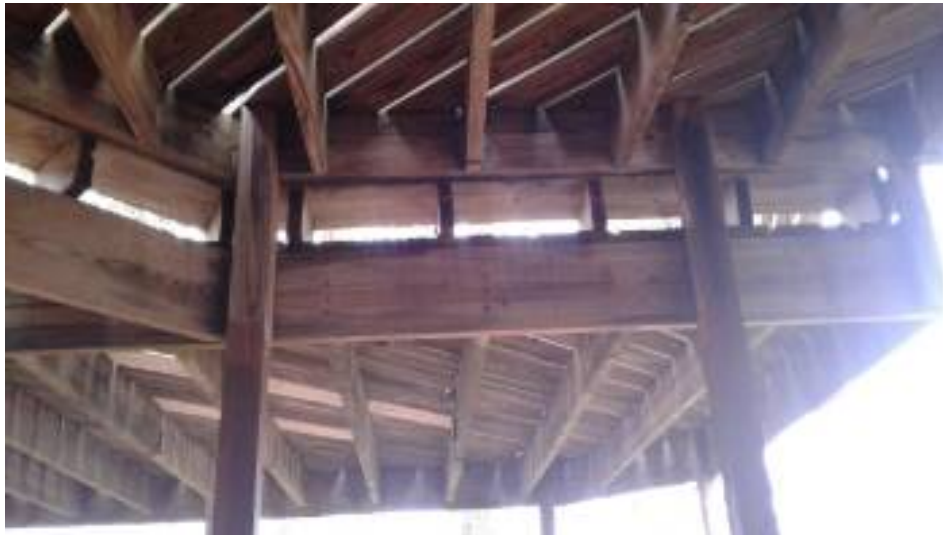
7. Decks & Steps

- **Rails missing in areas with drop offs of greater than 30 inches. Recommend installation of rails for safety.**
- **Spindle spacing exceeds the 4 inch spacing which is considered unsafe by today's child safety standards.**
- **Wood deterioration noted. Have repaired as necessary.**
- **Deck installed without supporting bracket hardware. Recommend installing brackets.**
- **No Lag Bolts Visible: The deck ledger board is nailed or screwed to the house, or is covered and not visible. Consider installing lag screws to securely attach ledger board to house, if they have not been used. By todays safety standards all decks should be built freestanding.**
- **Decks are not properly supported and are not built correctly. This is a safety hazard and needs repaired or replaced.**

| Exterior Areas | | |
|---|---|--|
| Page 7 Item: 7 | Decks & Steps | <ul style="list-style-type: none"> • Rails missing in areas with drop offs of greater than 30 inches. Recommend installation of rails for safety. • Spindle spacing exceeds the 4 inch spacing which is considered unsafe by today's child safety standards. • Wood deterioration noted. Have repaired as necessary. • Deck installed without supporting bracket hardware. Recommend installing brackets. • No Lag Bolts Visible: The deck ledger board is nailed or screwed to the house, or is covered and not visible. Consider installing lag screws to securely attach ledger board to house, if they have not been used. By today's safety standards all decks should be built freestanding. • Decks are not properly supported and are not built correctly. This is a safety hazard and needs repaired or replaced. |

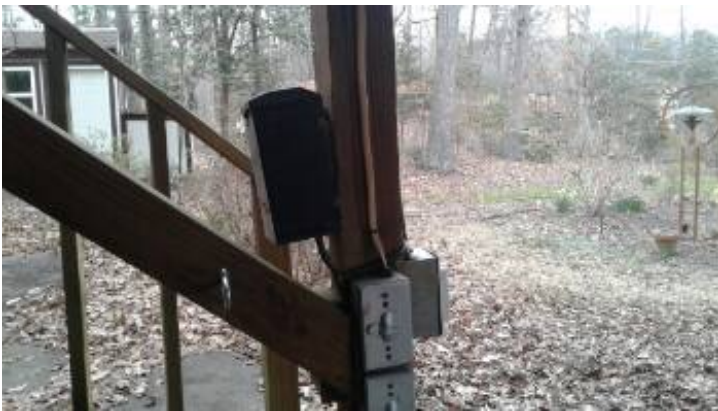
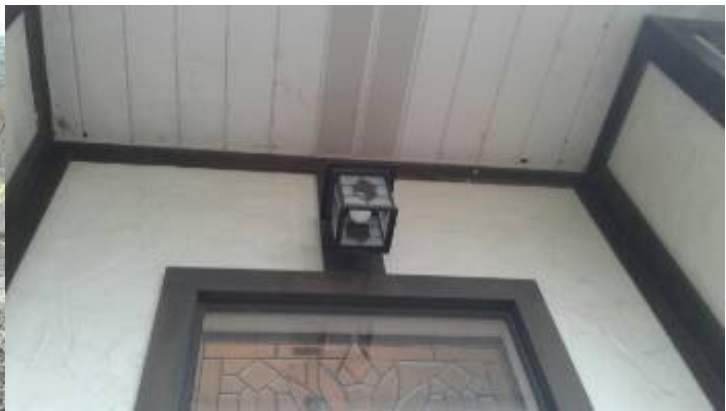
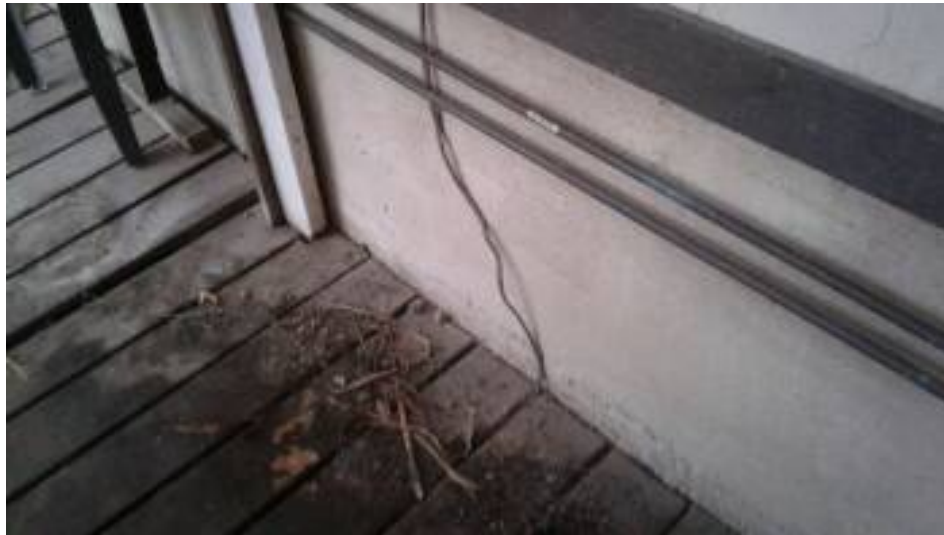
8. Electrical, Exterior

- Light fixture or bulb apparently inoperable in several areas . Change bulb(s) and check.
- **Exterior-rated Romex should be enclosed in conduit.**
- **Interior grade Romex should be replaced with exterior-rated Romex and enclosed in conduit.**

| Exterior Areas | | |
|---|---|--|
| Page 9 Item: 8 | Electrical, Exterior | <ul style="list-style-type: none"> • Exterior-rated Romex should be enclosed in conduit. • Interior grade Romex should be replaced with exterior-rated Romex and enclosed in conduit. |

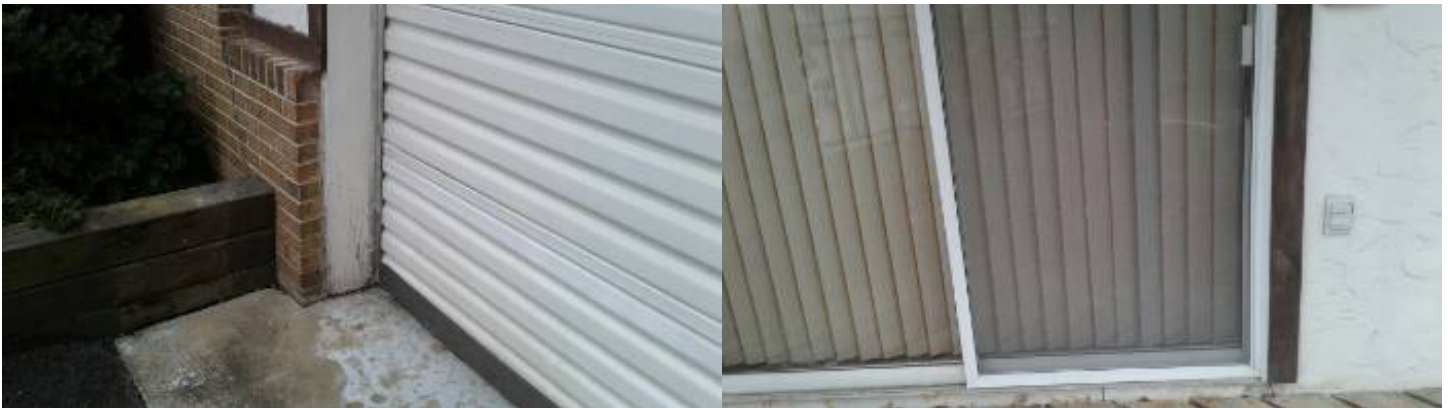
9. Doors

- Sliding door screen damaged
- **Door trim needs painted to prevent damage.**

| Exterior Areas | | |
|---|---|--|
| Page 10 Item: 9 | Doors | <ul style="list-style-type: none"> • Door trim needs painted to prevent damage. |

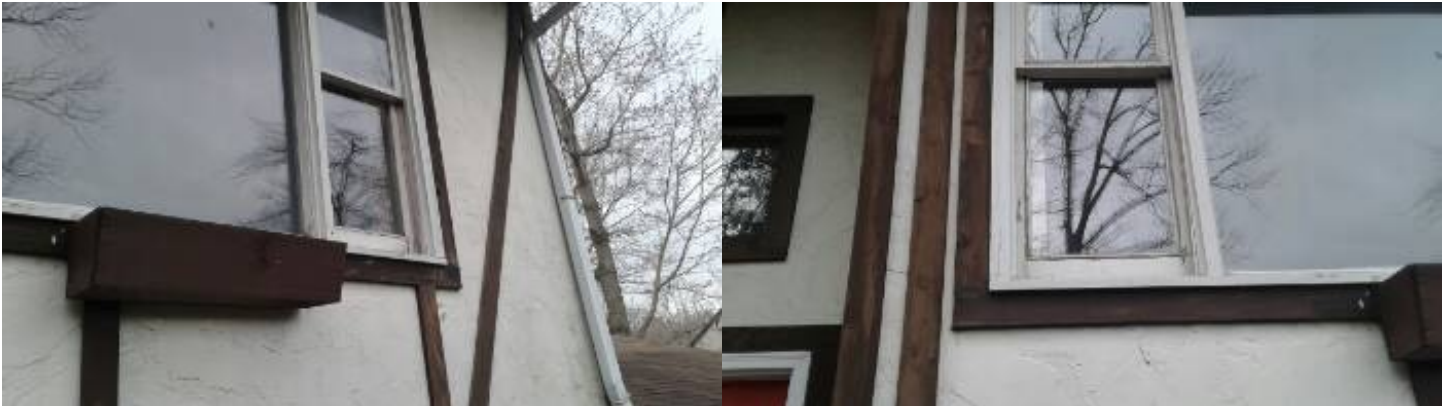
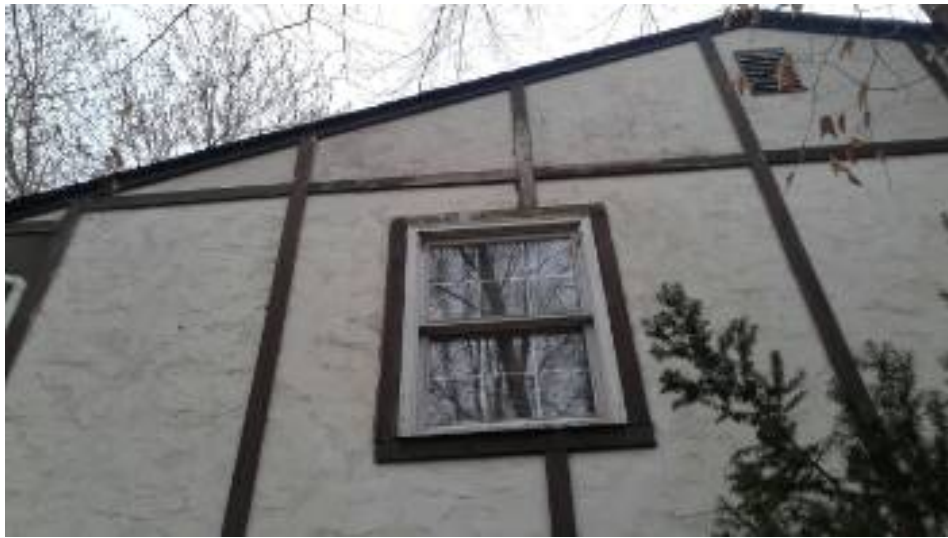
10. Window Condition

- Some window screens missing.
- **Deteriorated frame(s) noted in several areas. Have evaluated and replaced.**

| Exterior Areas | | |
|---|---|--|
| Page 10 Item: 10 | Window Condition | <ul style="list-style-type: none"> • Deteriorated frame(s) noted in several areas. Have evaluated and replaced. |

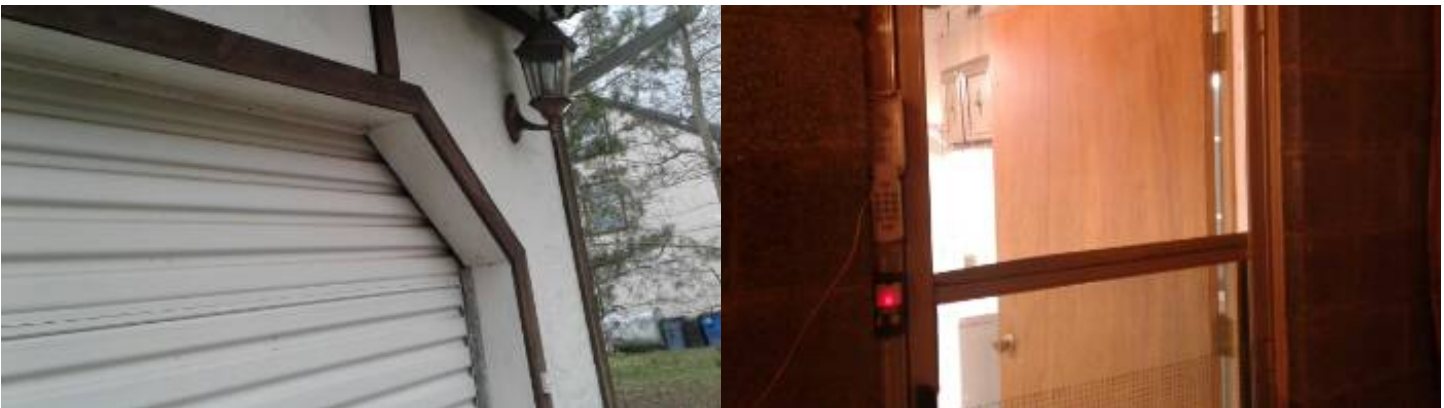
1. Garage

- Garage-house door weatherstrip damage.
- **Garage-house door is not properly fire-rated. Have evaluated and repaired.**

| Page 12 Item: 1 | Garage | <ul style="list-style-type: none"> • Garage-house door is not properly fire-rated. Have evaluated and repaired. |

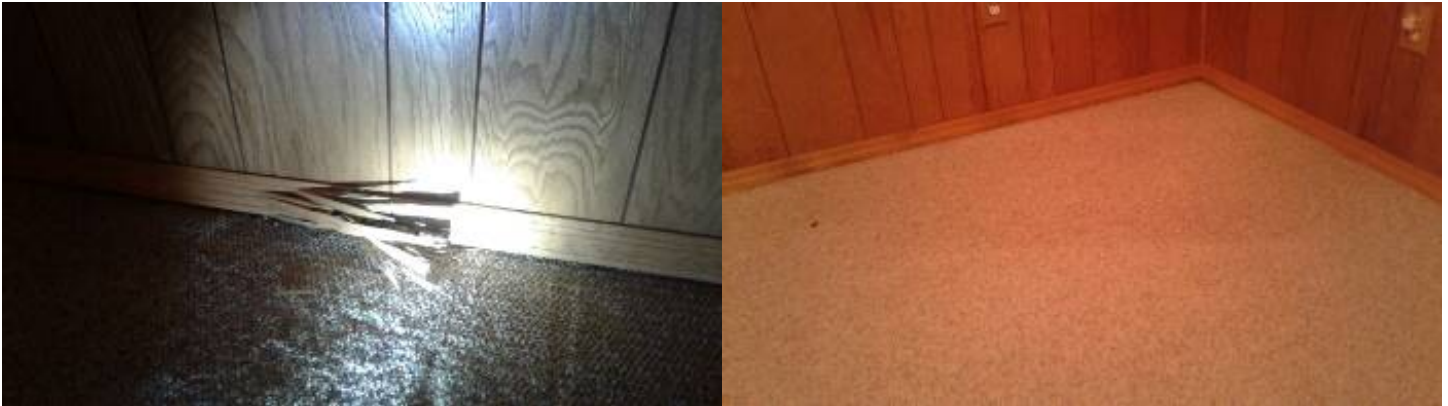
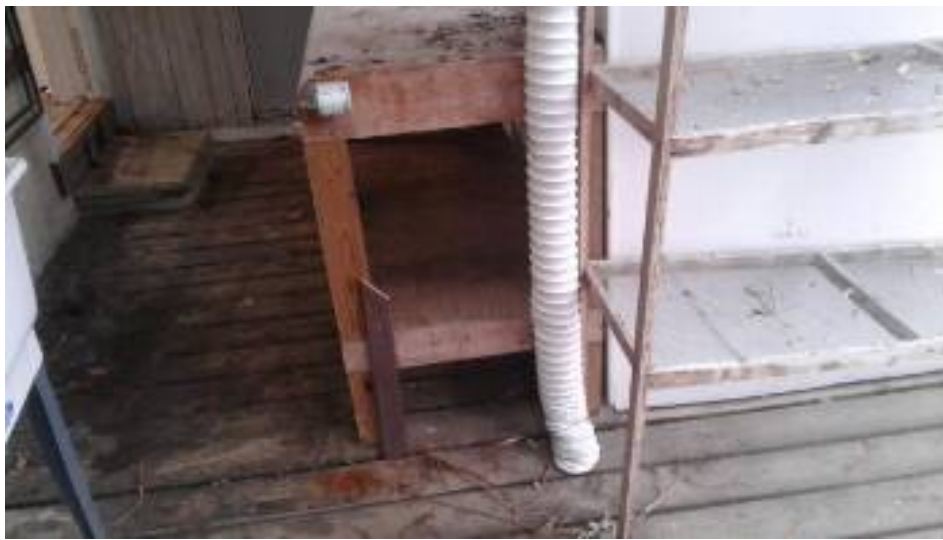
2. Basement / Crawlspace

- Inspection Method: Traversed
- Insulation not visible, finished basement.
- Ductwork noted in the green house.
- **Possible water intrusion noted in basement. Front bedroom.**
- **Termite mud tubs noted in basement. Have evaluated and treated.**

| Page 12 Item: 2 | Basement / Crawlspace | <ul style="list-style-type: none"> • Possible water intrusion noted in basement. Front bedroom. • Termite mud tubs noted in basement. Have evaluated and treated. |

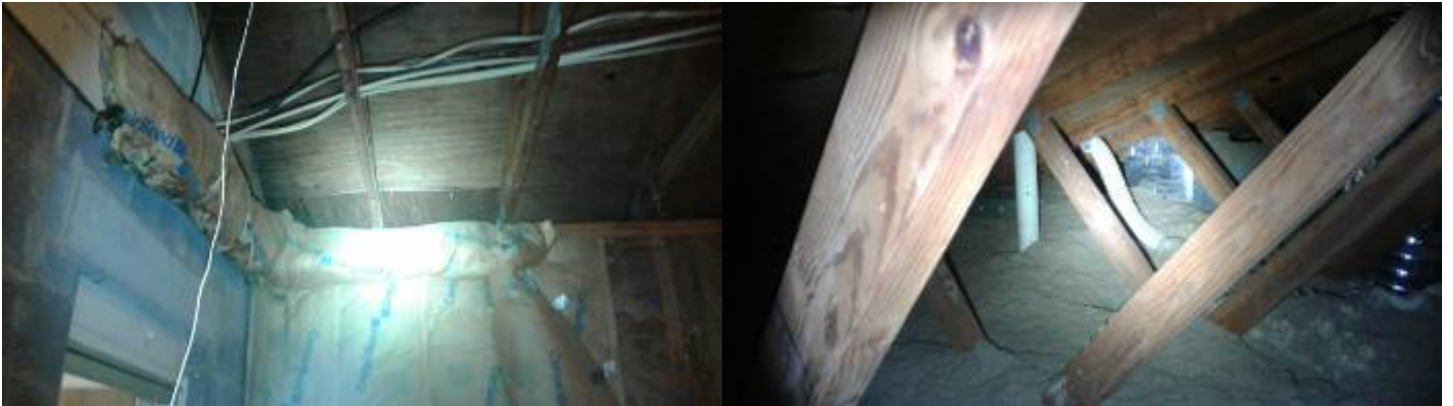
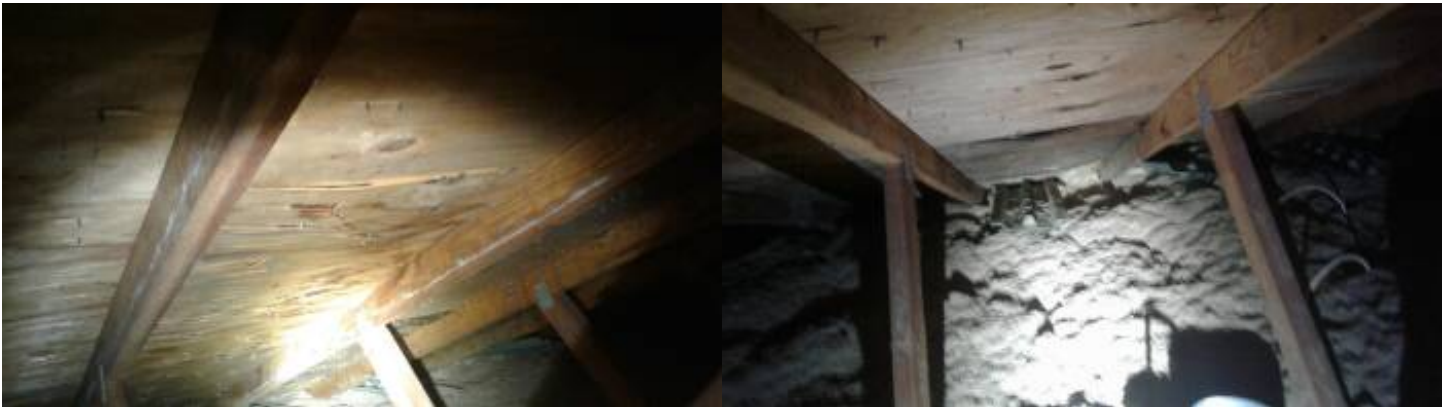
3. Attic

- Traversed
- **Cellulose** Insulation
- Insulation averages about 6-8 inches in depth
- **Exhaust fan duct appears to terminate in attic. Have duct routed to exterior to minimize moisture.**
- **Evidence of present leaks. (See roofing notes)**
- **Subroofing damage noted in several areas. See roofing notes.**

| Page 13 Item: 3 | Attic | <ul style="list-style-type: none"> • Exhaust fan duct appears to terminate in attic. Have duct routed to exterior to minimize moisture. • Evidence of present leaks. (See roofing notes) • Subroofing damage noted in several areas. See roofing notes. |

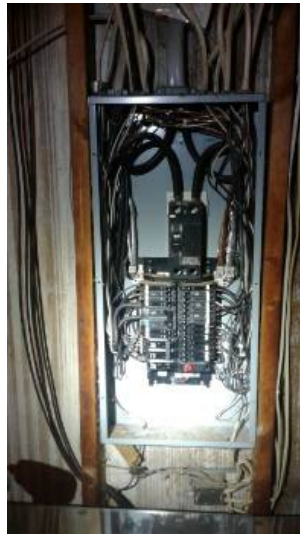
Materials: Underground Service, 200 Amp Service, Main Disconnect in panel box, Panel box located in garage., GE
Observations:

- No major system safety or function concerns noted at time of inspection at main panel box.

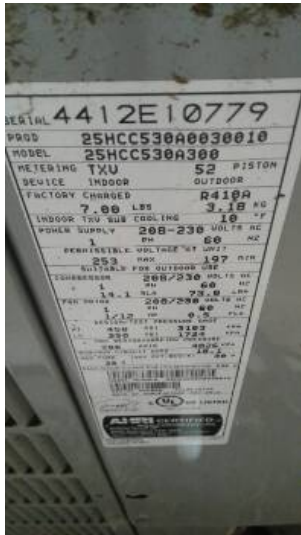
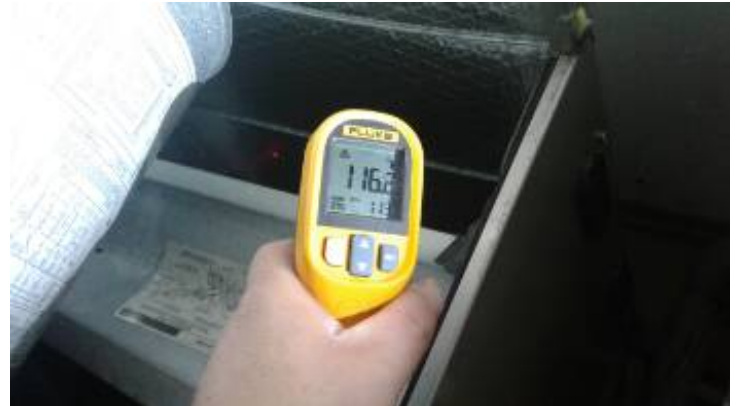
2. HVAC Unit

Observations:

- No major system safety or function concerns noted at time of inspection.

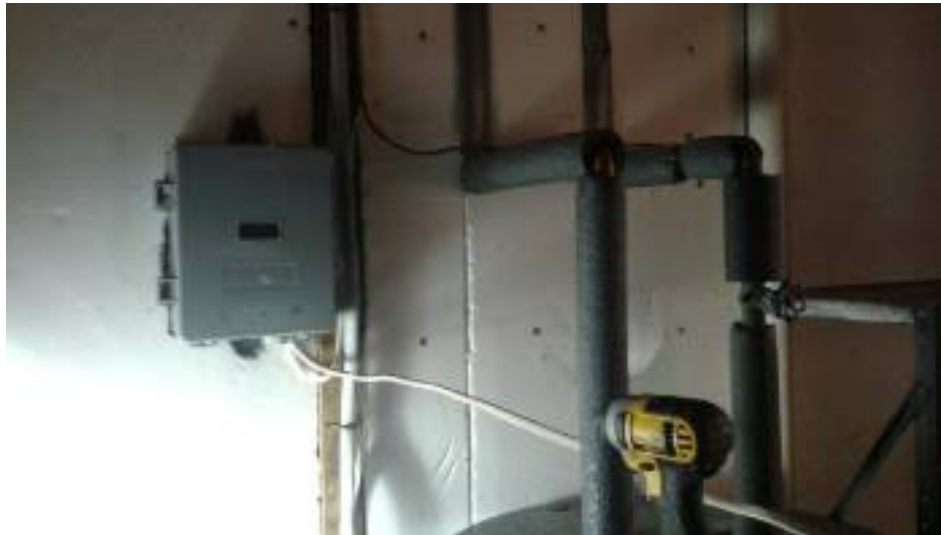
3. Water Heater

- No **expansion tank** noted above hot water heater. One should be installed to prevent TRV valve blow off.
- No disconnect switch/box noted next to hot water heater. Have evaluated and repaired.

| Page 16 Item: 3 | Water Heater | <ul style="list-style-type: none"> • No expansion tank noted above hot water heater. One should be installed to prevent TRV valve blow off. • No disconnect switch/box noted next to hot water heater. Have evaluated and repaired. |

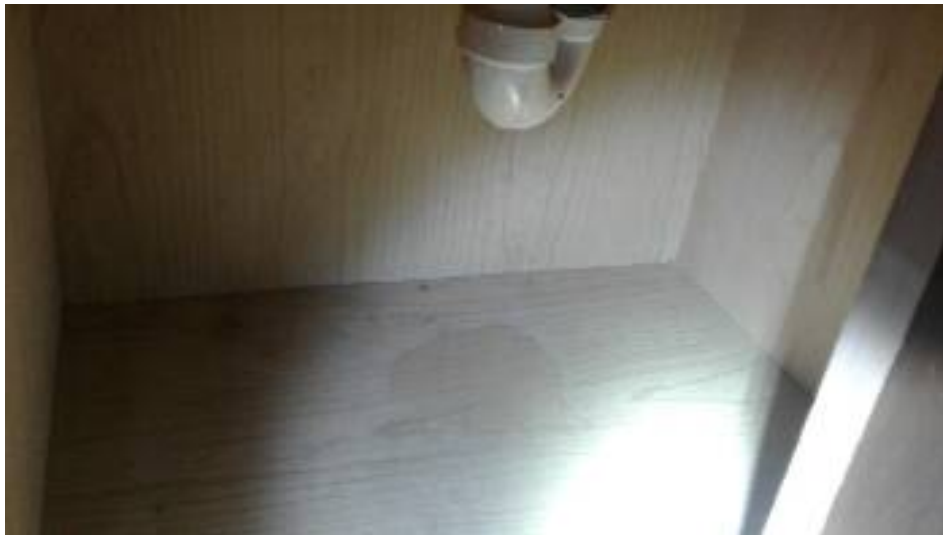
2. Master Bath

- Sink drain line leaks. Recommend repair by professional plumber.

| Page 18 Item: 2 | Master Bath | <ul style="list-style-type: none"> • Sink drain line leaks. Recommend repair by professional plumber. |

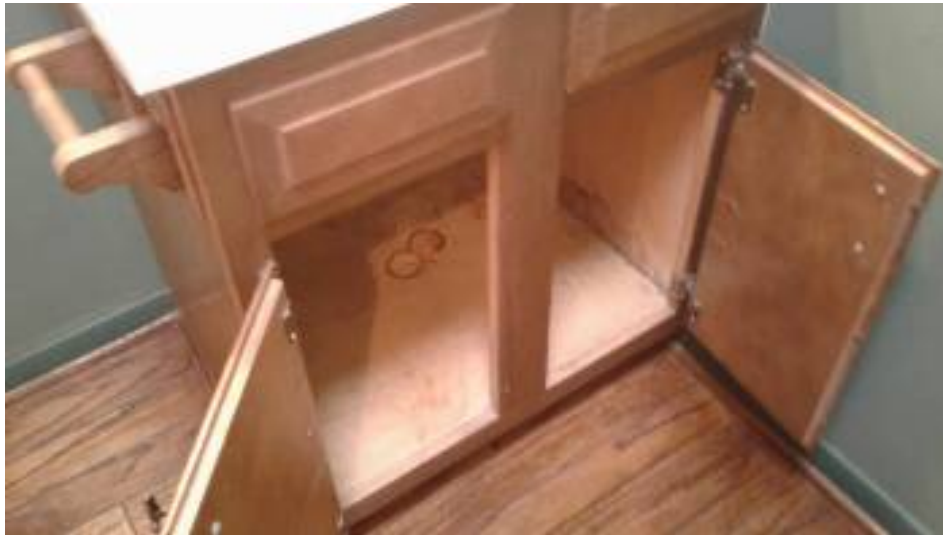
3. Bath

- LOCATION: Hall
- Vanity damaged.

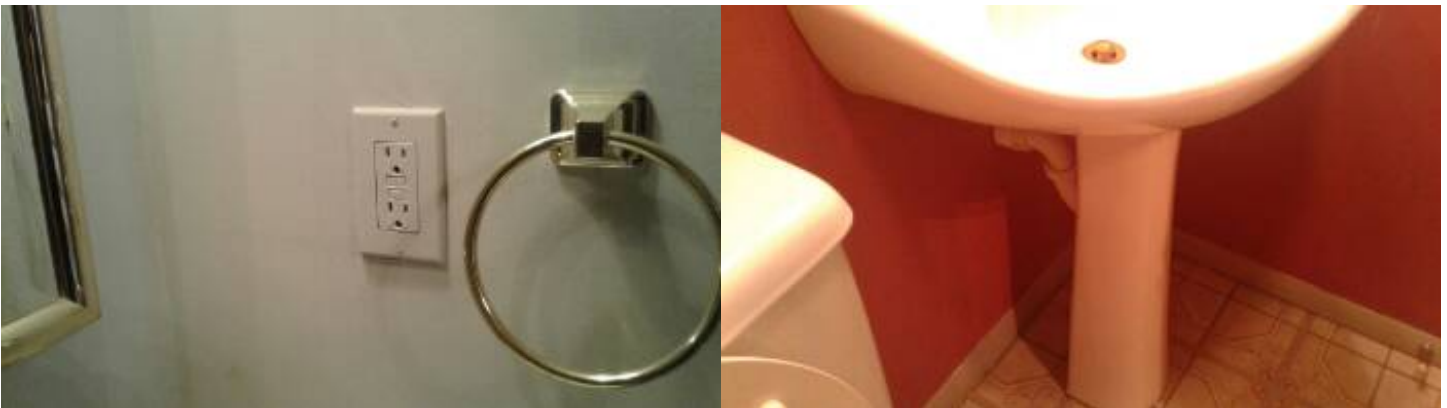
5. Bath (Guest)

- LOCATION: Basement
- **GFCI trip test failed. Have electrician evaluate.**
- **Sink drain line leaks. Recommend repair by professional plumber.**

| Page 19 Item: 5 | Bath (Guest) | <ul style="list-style-type: none"> • GFCI trip test failed. Have electrician evaluate. • Sink drain line leaks. Recommend repair by professional plumber. |

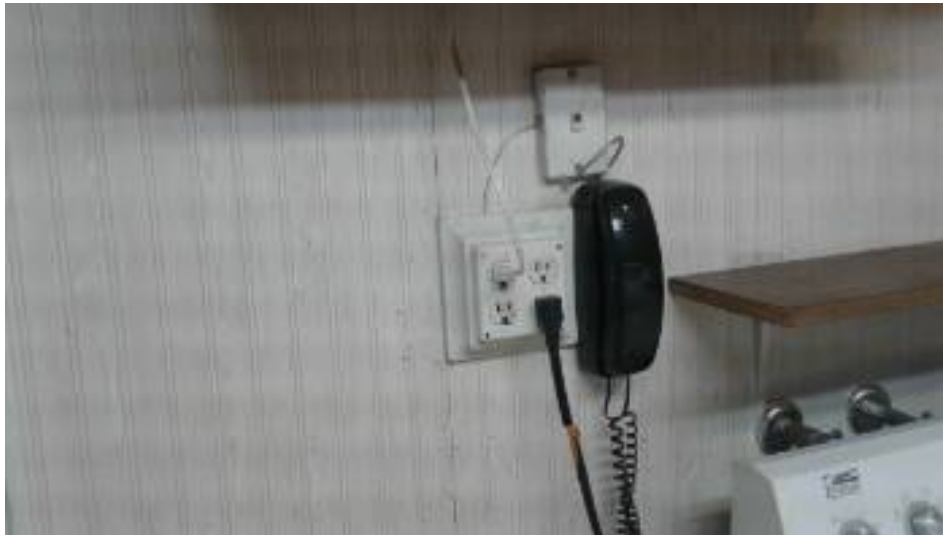
7. Plumbing & Laundry

- **No GFCI outlets visible, which is common for a home of this age. Consider installing protected outlets.**

| Page 19 Item: 7 | Plumbing & Laundry | <ul style="list-style-type: none"> • No GFCI outlets visible, which is common for a home of this age. Consider installing protected outlets. |

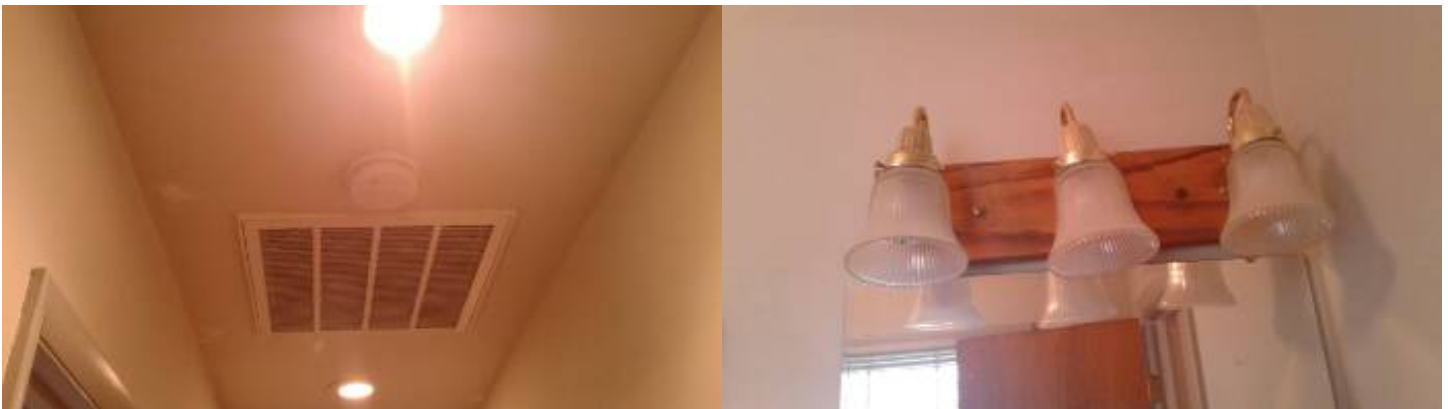
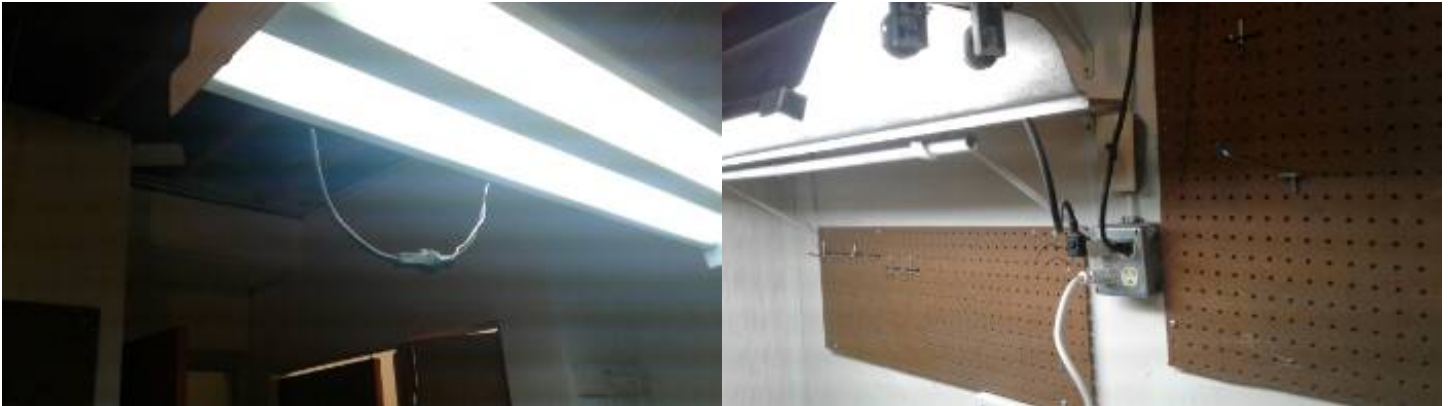
8. Interior Electric

- Light fixture or bulb apparently inoperable in several areas . Change bulb(s) and check.
- **Smoke detectors missing in bedrooms. Installation recommended.**
- **Extension cord in use as hardwire. Have evaluated and repaired. In laundryroom**

| Page 20 Item: 8 | Interior Electric | <ul style="list-style-type: none"> • Smoke detectors missing in bedrooms. Installation recommended. • Extension cord in use as hardwire. Have evaluated and repaired. In laundryroom |

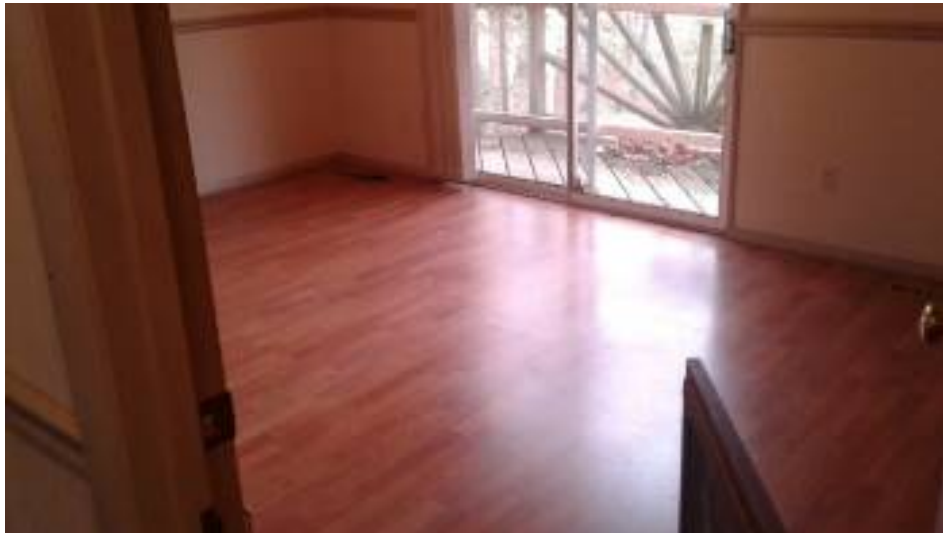
9. Floors, Ceilings & Walls

- **Sloping floor and/or bulges/dips in floor. Determining the exact cause of any sloping/bulges/dips would require removal of the floor covering or other destructive testing, which is not within the scope of the home inspection. Note that this phenomena is common for a house of this age, but a structural engineer or contractor should be consulted to verify integrity of structure. Most likely the outside deck is pushing up the flooring in the master bedroom.**

| Page 21 Item: 9 | Floors, Ceilings & Walls | <ul style="list-style-type: none"> • Sloping floor and/or bulges/dips in floor. Determining the exact cause of any sloping/bulges/dips would require removal of the floor covering or other destructive testing, which is not within the scope of the home inspection. Note that this phenomena is common for a house of this age, but a structural engineer or contractor should be consulted to verify integrity of structure. Most likely the outside deck is pushing up the flooring in the master bedroom. |

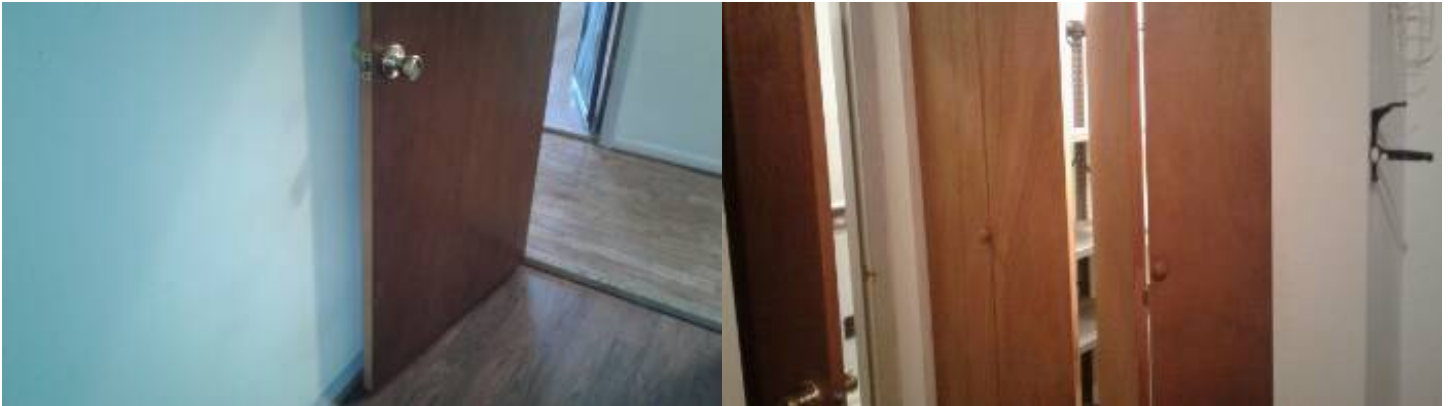
10. Doors

- Door binds in jamb (basement bi-fold).
- Some door stop(s) missing / ineffective; recommend installation to avoid unnecessary wall or door damage.

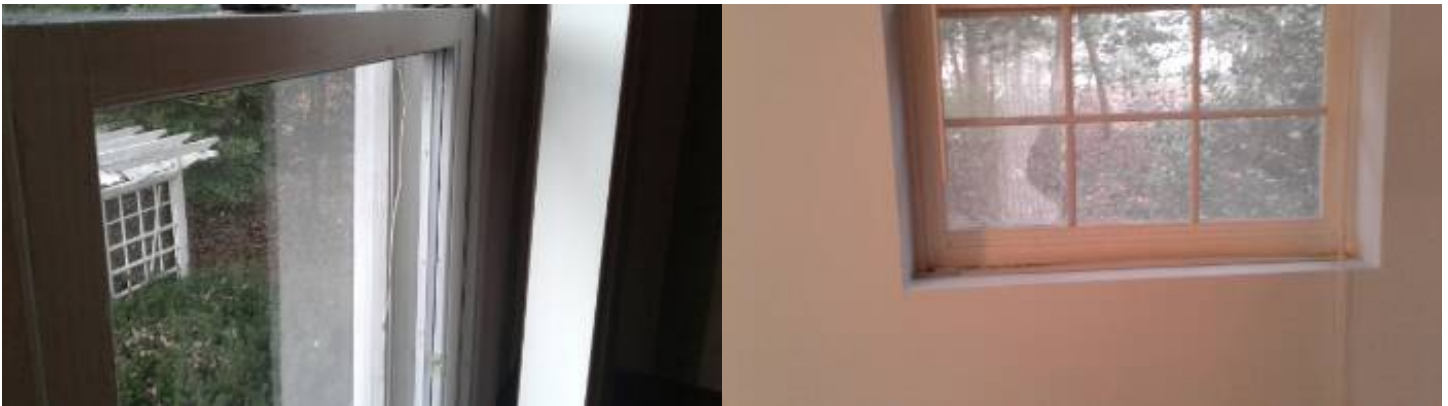
11. Windows

- **Window binds in frame in basement.**
- **Sash ropes need repair for proper window operation.**

| Page 22 Item: 11 | Windows | <ul style="list-style-type: none"> • Window binds in frame in basement. • Sash ropes need repair for proper window operation. |

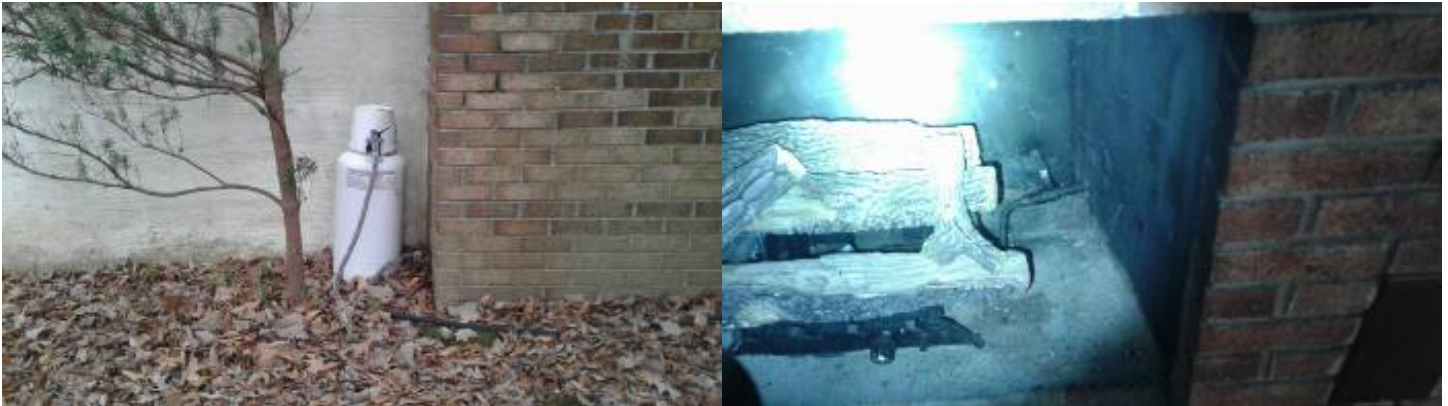
12. Fireplaces & Stoves

- Have Chimney Inspected - The National Fire Protection Association (www.nfpa.org) advises that each chimney receive a Level II inspection each time a residence is sold. Inspection levels are explained at www.csia.org/pressroom/press-inspection-levels-explained.htm. It is also advised that this inspection be conducted by a chimney sweep certified by the Chimney Safety Institute of America (www.csia.org).
- Wood fire place has been replaced with gas logs. Have system evaluated for proper ventilation.
- Gas Fireplace does not appear to start with a wall switch. Have seller demonstrate operation.
- **Gas tank and lines need to be evaluated and replaced as needed.**

| Page 22 Item: 12 | Fireplaces & Stoves | <ul style="list-style-type: none"> • Gas tank and lines need to be evaluated and replaced as needed. |
