CQI Home Inspections

Your Property Inspection Report

22166 Monterey Pl, Leonardtown , MD 20650

Inspection prepared for: Sample

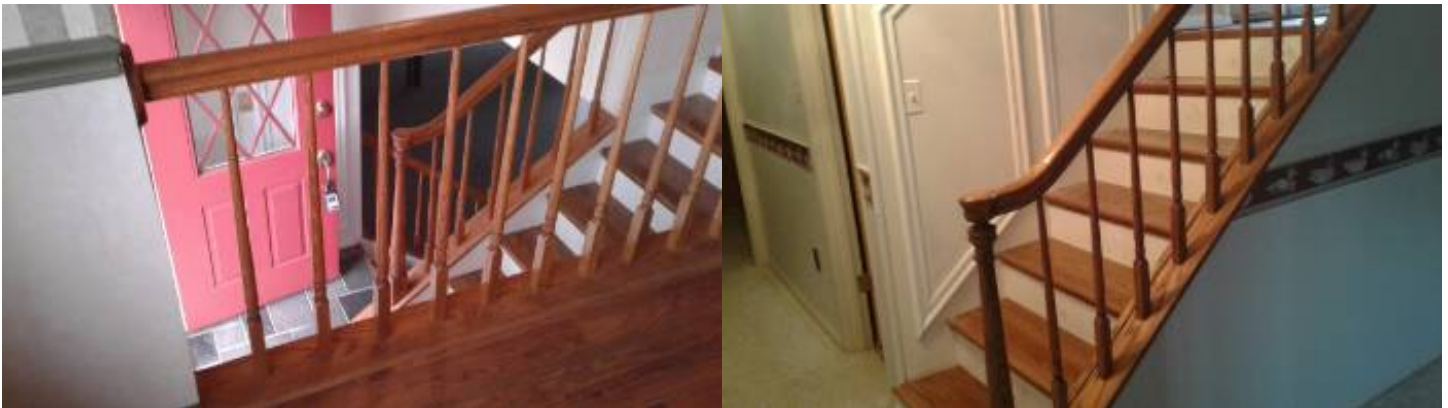
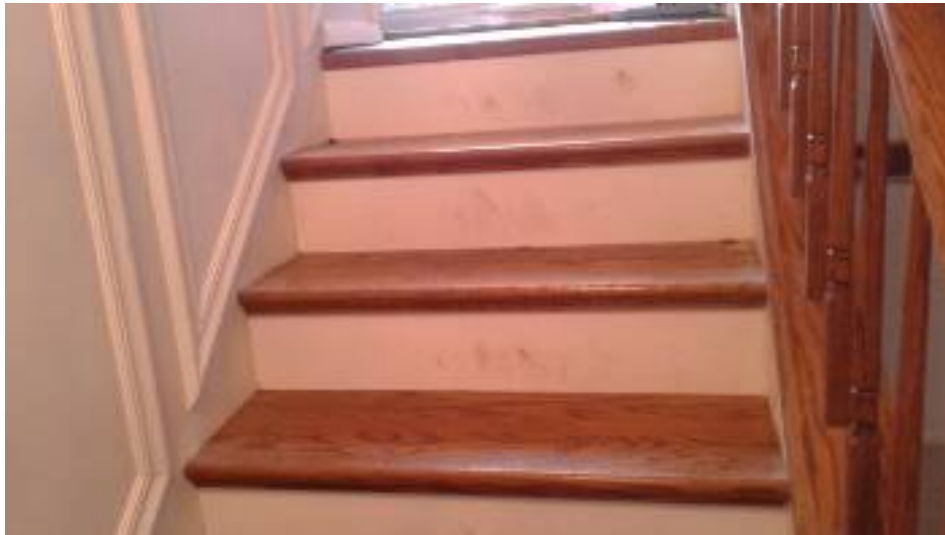
13. Stairways

- **Several steps are loose.**
- **Spindles exceeds 4 inch spacing, which is considered unsafe by today's standards.**
- **Hand Rail Components loose.**

| Page 23 Item: 13 | Stairways | <ul style="list-style-type: none"> • Several steps are loose. • Spindles exceeds 4 inch spacing, which is considered unsafe by today's standards. • Hand Rail Components loose. |
